CITY OF CITRUS HEIGHTS

DRAFT ADA TRANSITION PLAN UPDATE

NEIGHBORHOOD AREA 11 BIRDCAGE HEIGHTS

SEPTEMBER 20, 2011

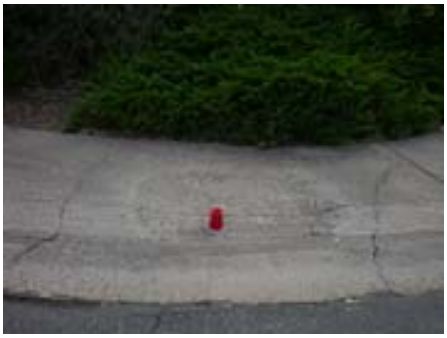
Field Date: 5/31/2011 Report Date: 5/31/2011 Barrier #: 8568
Location: Eastgate Ave - East
X Coordinate: -121.2818
Y Coordinate: 38.66742
Barrier Area: Sidewalks
Barrier Type: Cross Slope - Existing (3.1% to 4.0%)
Code Ref: CBC 1133B.7.1.3 and ADA/ABA 403.3
As Built Meas: 101 Quantity: LF
Description: Cross slope exceeds 2.0% (3.1% to 4.0%)
As Built Desc: 3.7% cross slope
Solution: Demolish existing and construct new route
Bar. Severity: 3 Hindrance Cost Estimate: $12,625.00 Status:
Implementation Priority: 4 Facility Function:
Implementation Phase: Implementation Date:
Official Responsible:
Notes:
